**FINAL
FISH AND WILDLIFE COORDINATION ACT REPORT**

**LELOALOA SHORELINE PROTECTION PROJECT
ISLAND OF TUTUILA
AMERICAN SAMOA**

AUGUST 2005

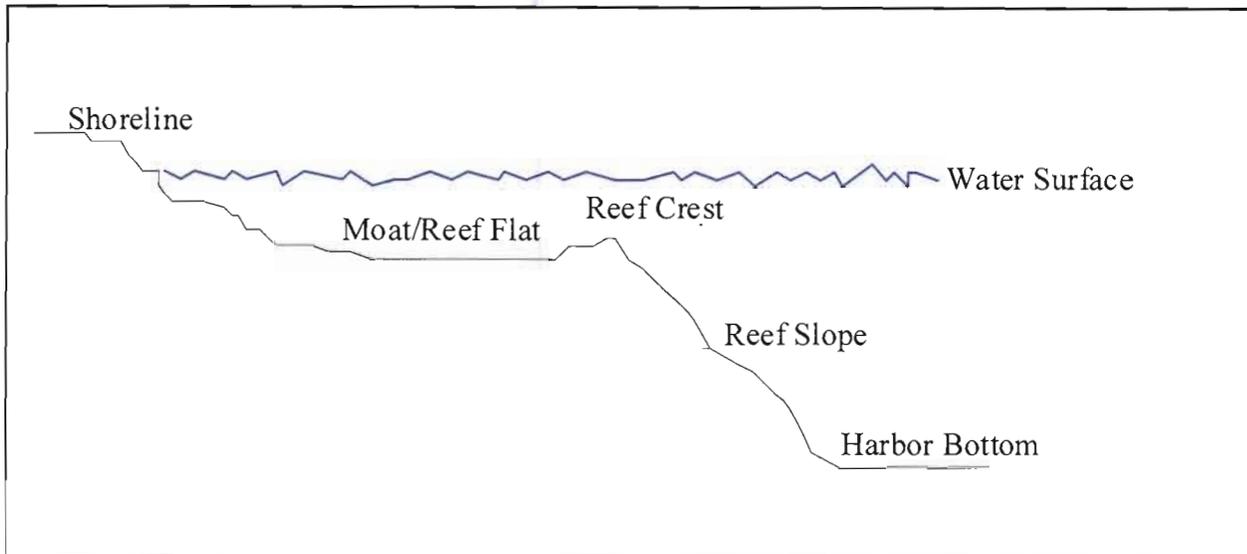
Figure 3. Stylized fringing coral reef habitat profile, Pago Pago Harbor, American Samoa

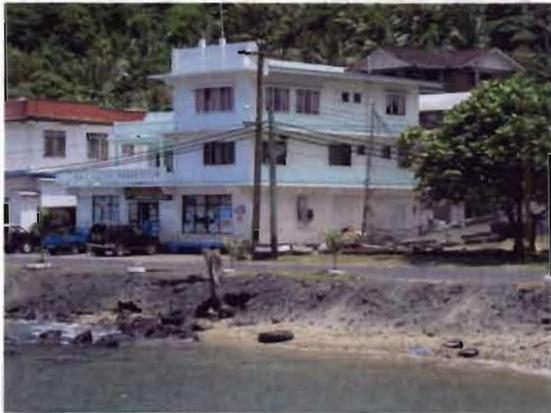
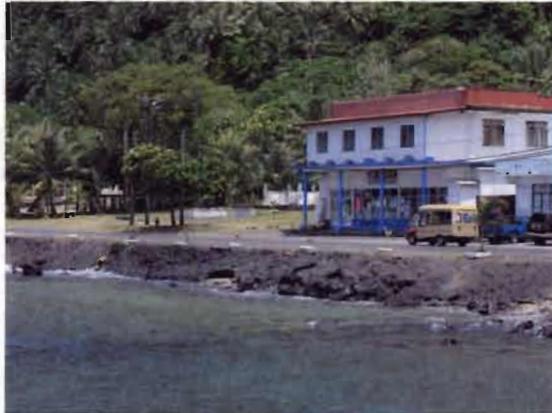
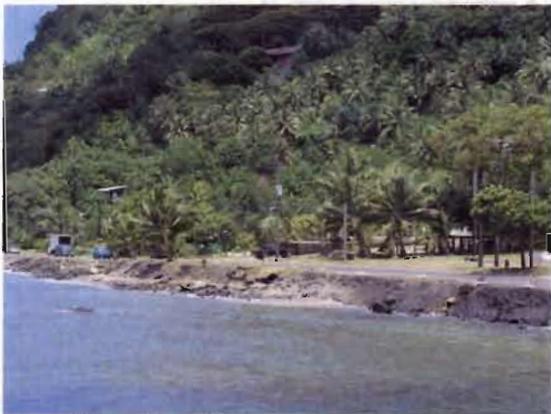
West View - Shoreline

APPENDIX 3. Photo sequence for the project area at Leloaloe, Pago Pago Harbor,
American Samoa

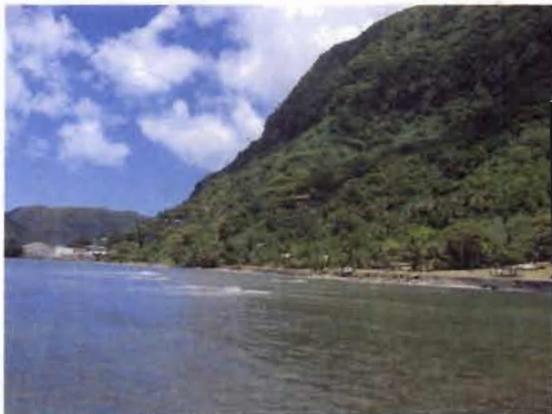
West View - Reef Flat and Shoreline

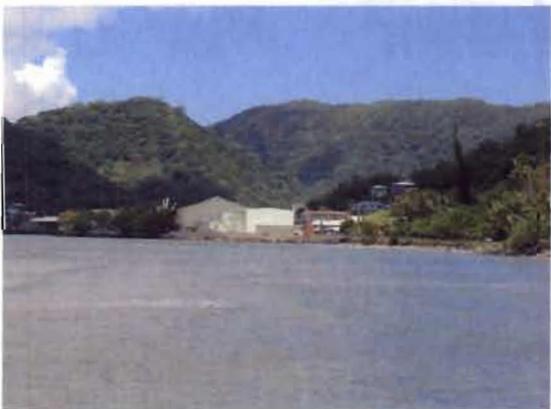
West View - Reef Flat

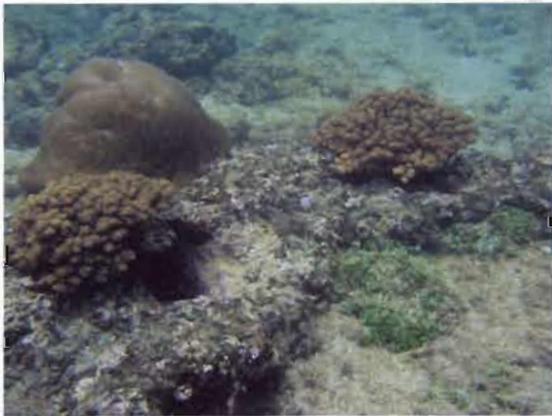
Coral Community

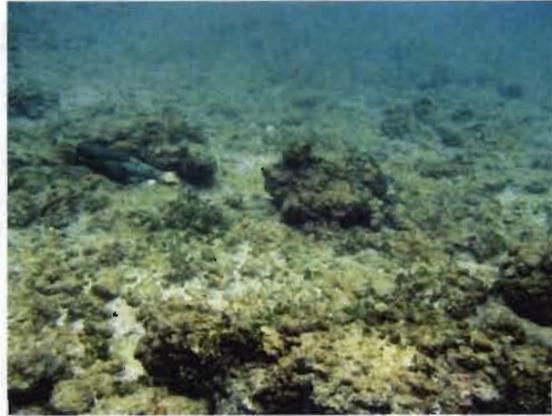
Reef Substrate

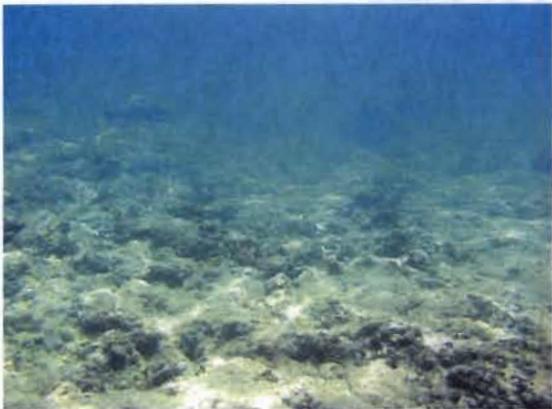
Reef Substrate

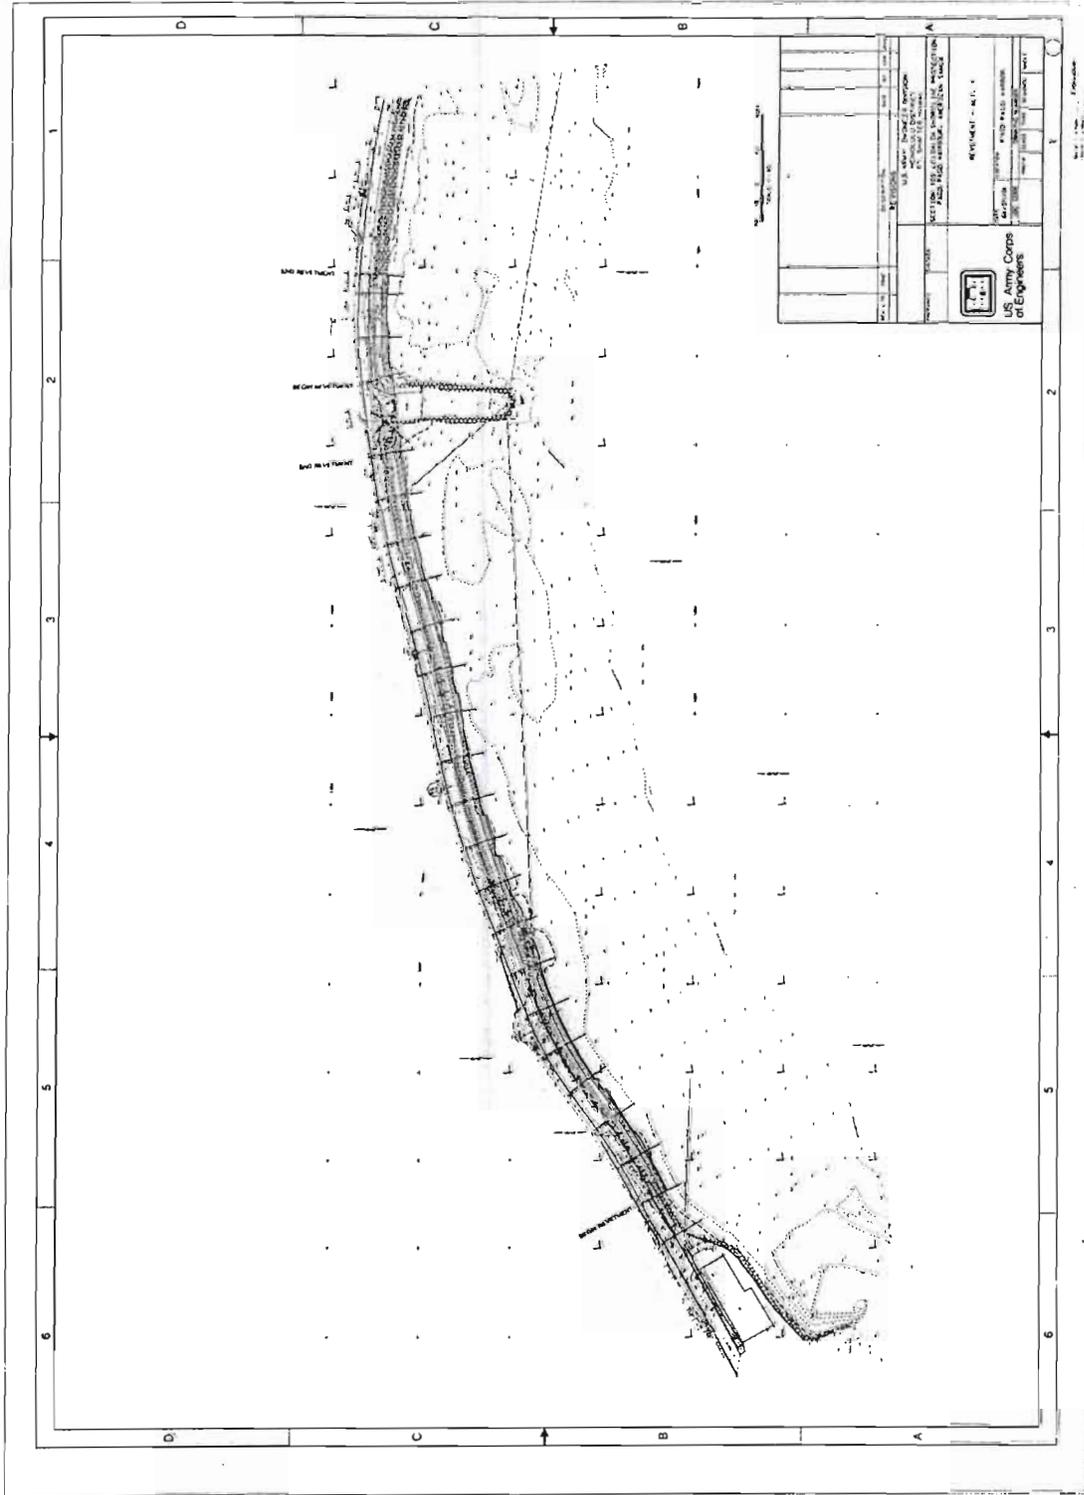
APPENDIX 5a. Plan proposed of shoreline revetment, Leloaloe, Pago Pago Harbor, American Samoa (Source: U.S. Army Corps of Engineers, Honolulu District)

Based on the existing need for the proposed project and on the anticipated project-related impacts, we support the construction of a rock revetment to stabilize the Leloaloea shoreline. We recommend development of a compensatory mitigation plan that includes an appropriate monitoring plan and performance standards, including appropriate contingency planning, should the proposed measures fail to achieve expected results to offset the anticipated unavoidable impacts to fish and wildlife resources by the proposed project. Also, we recommend that the mitigation plan be finalized prior to implementation of project construction activities.

- (2) **Revetment Slope:** Model and design the revetment, prior to construction, with sufficient slope to reduce significant back-wash wave energy from being projected in a seaward direction onto the reef flat. Reduction of back-wash wave energy may minimize transporting rubble from the shallows and forming deposits on the mid reef flat that may scour and degrade coral, coralline algae, or macro-algae.

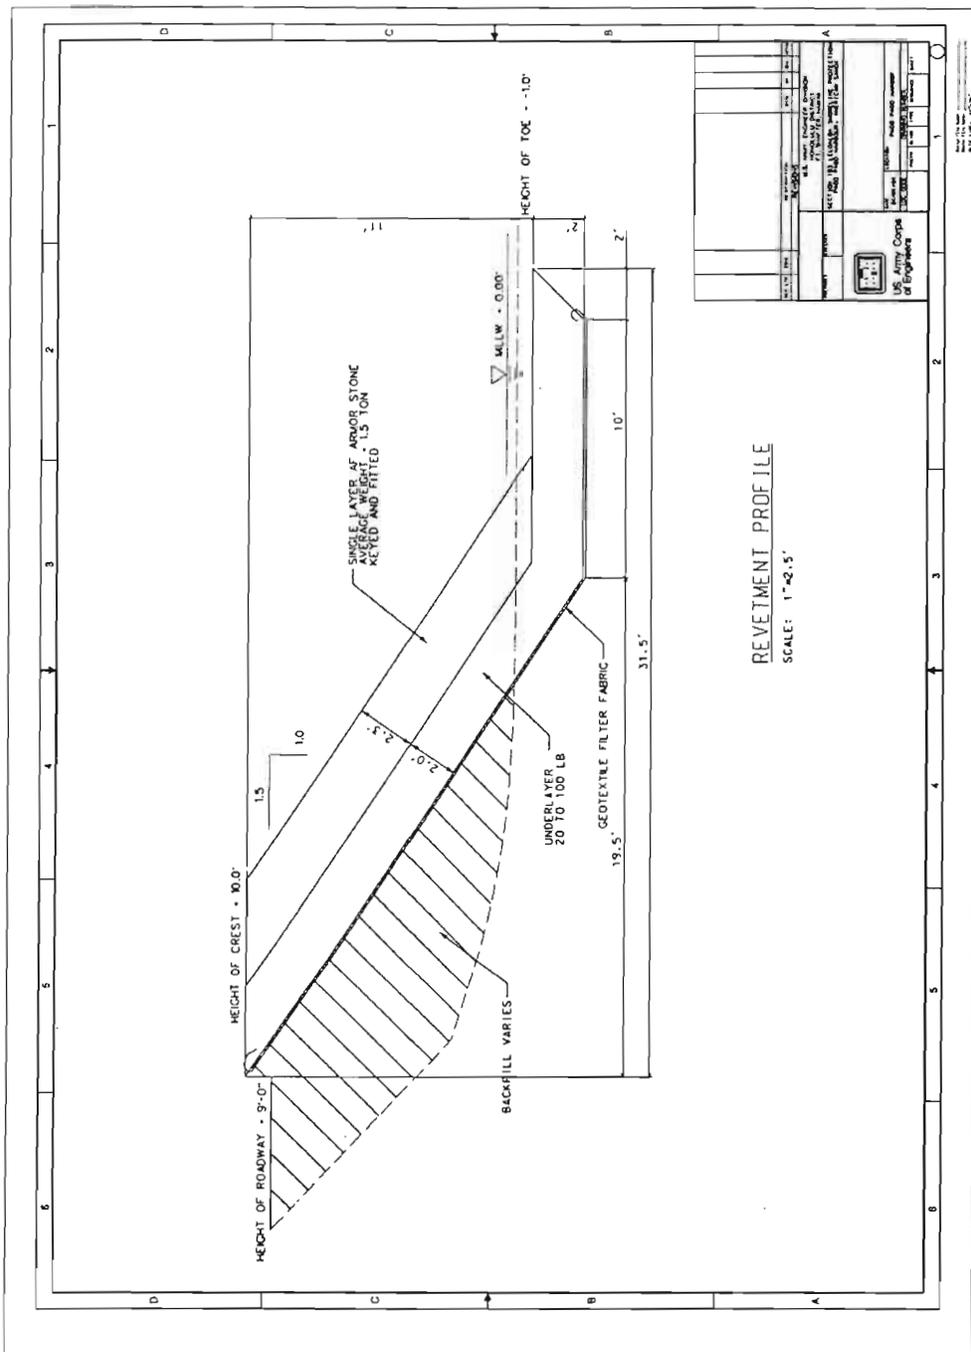
APPENDIX 5b. Plan profile of proposed shoreline revetment, Leloaloe, Pago Pago Harbor, American Samoa (U.S. Army Corps of Engineers, Honolulu District)
