Large Scale Coastal Tidal Marsh and Barrier Beach Restoration at Prime Hook NWR – Recovering from Hurricane Sandy and Building Resilience in Former Freshwater Impoundments.

**Storming Back:
Restoration, Resiliency and Readiness
at Northeast National Wildlife Refuges**

Marsh Interior Restoration Sandy Resiliency Project

Beach, Dune and Backbarrier Restoration Sandy Recovery Project

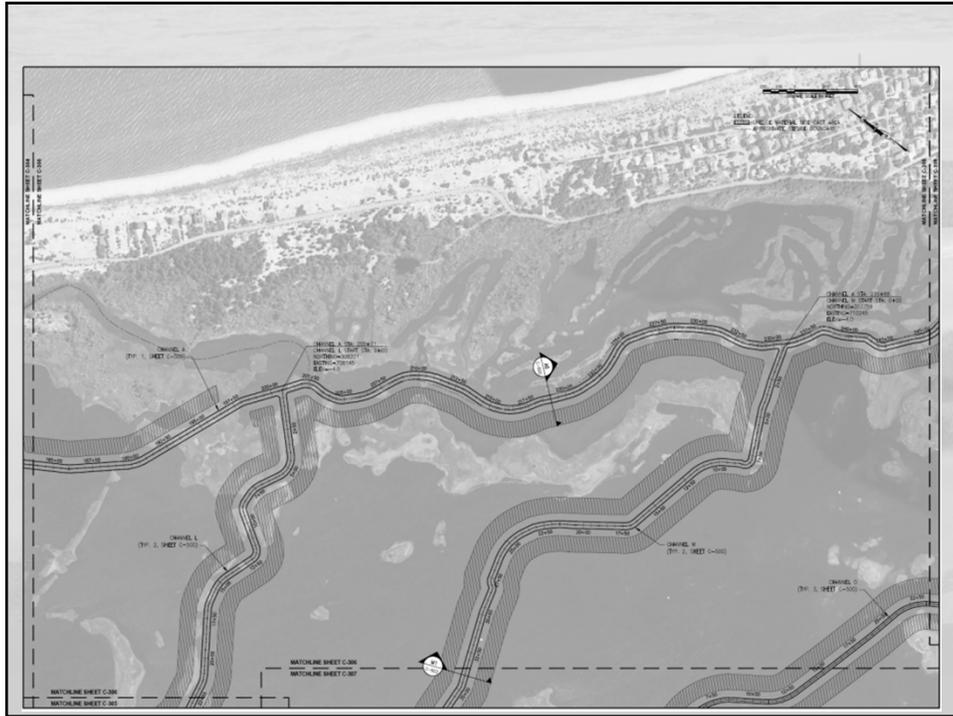
10" Shallow Draft Dredges

3 Dredges

- *Begin to rebuild ecosystem processes*
- Improve tidal circulation by creating conveyance channel network
 - ~ 25 Miles of channels -
- Use material from on-site dredging work to restore lost elevation in some areas of the marsh interior (thin-layer application)
 - Kinda.....more of a disposal mechanism
 - ~600,000 cy

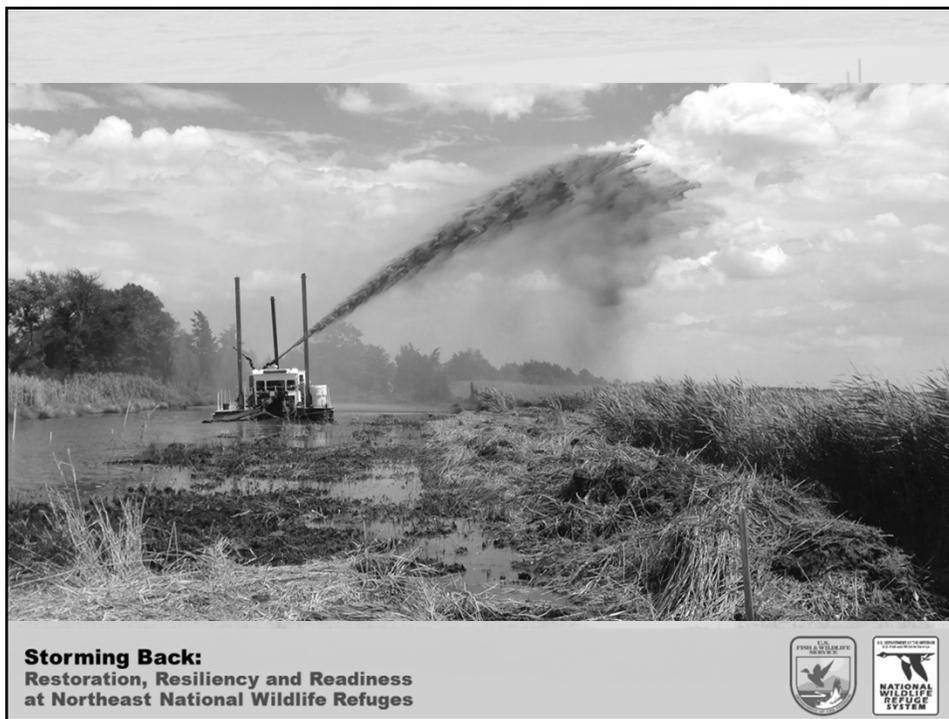
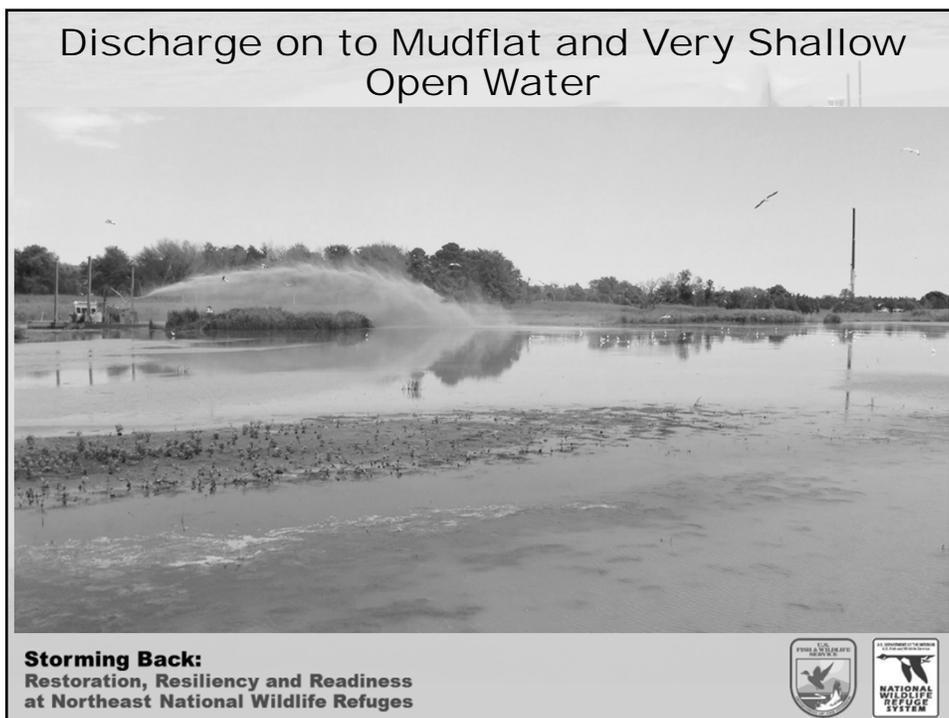
Discharge on to Shallow Open Water

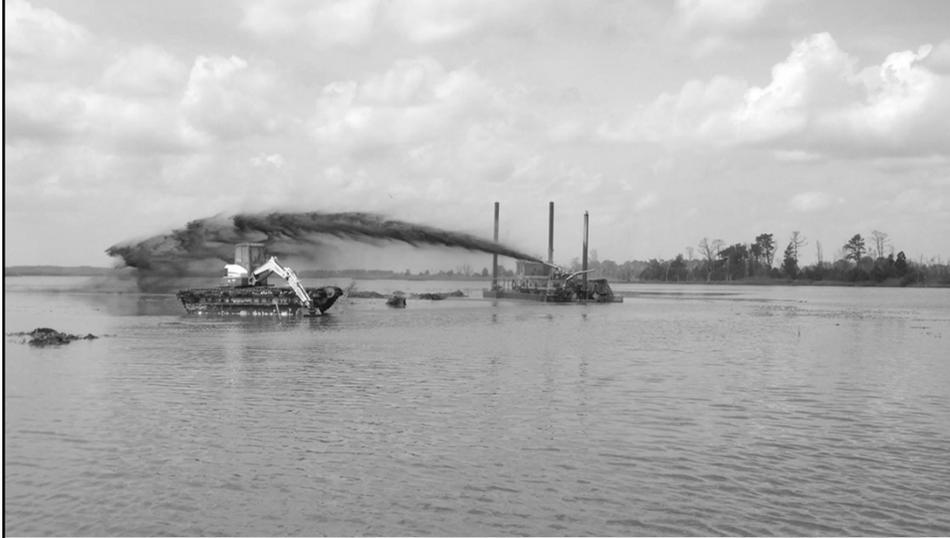
Berming to Avoid Sediment Inflowing

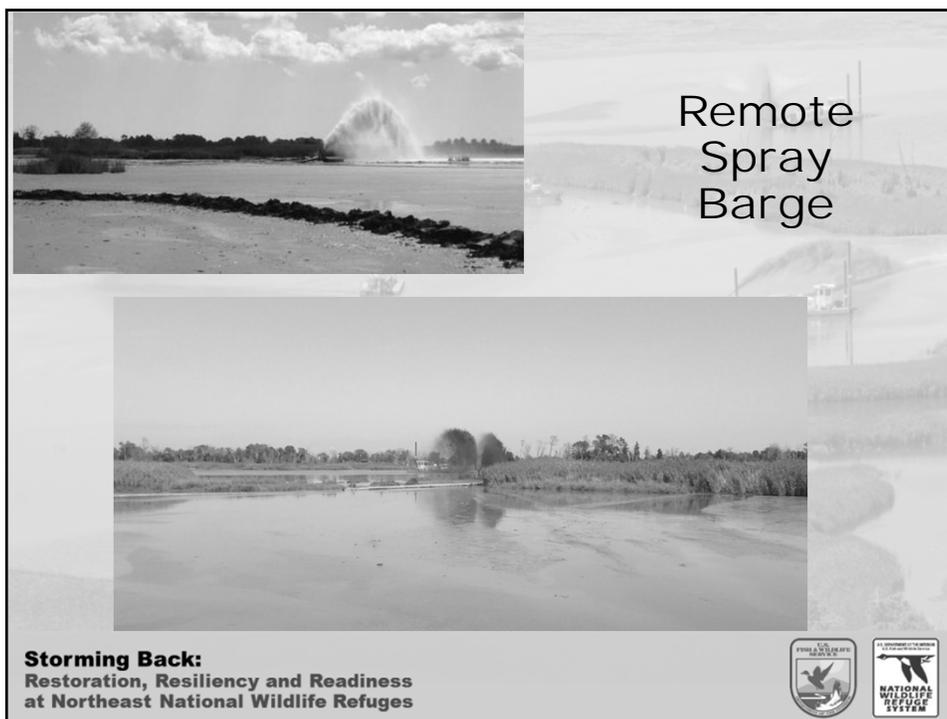
Remote
Spray
Barge

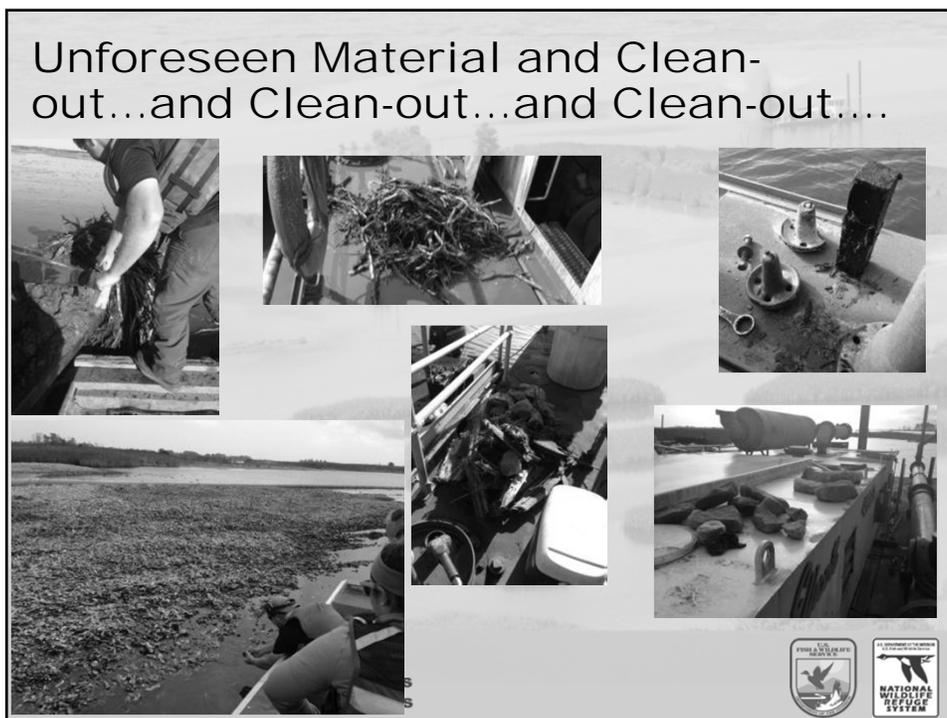
Unforeseen Material and Clean-out...and Clean-out...and Clean-out...

Heterogeneous Material

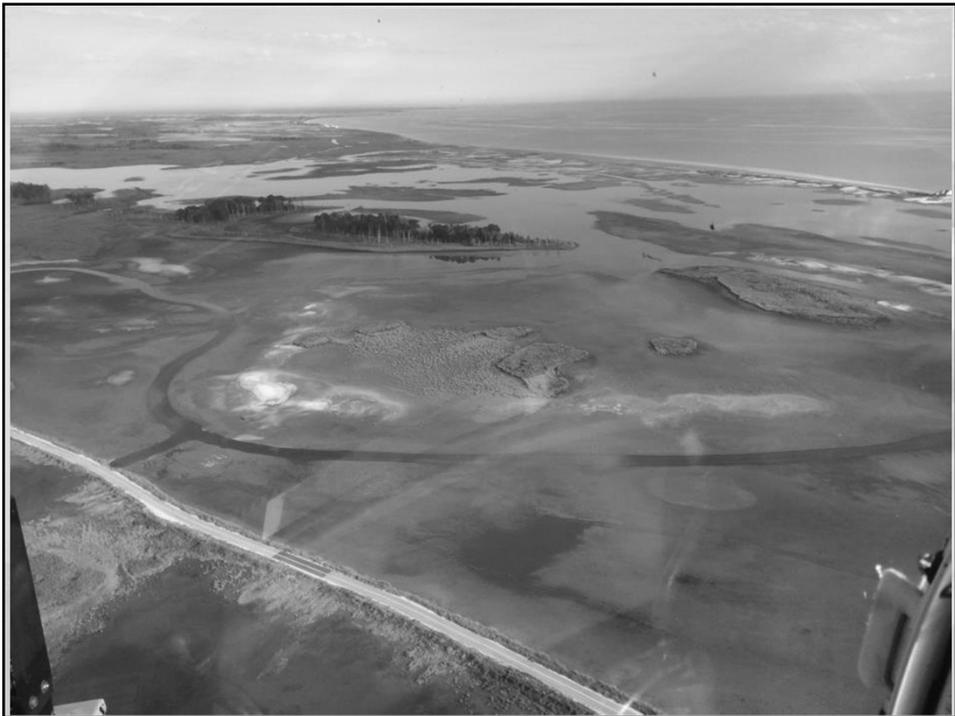
Aerial Seeding

- Used over 10,000 lbs of seed from 17 different species
- 1,000 acres of exposed mudflat

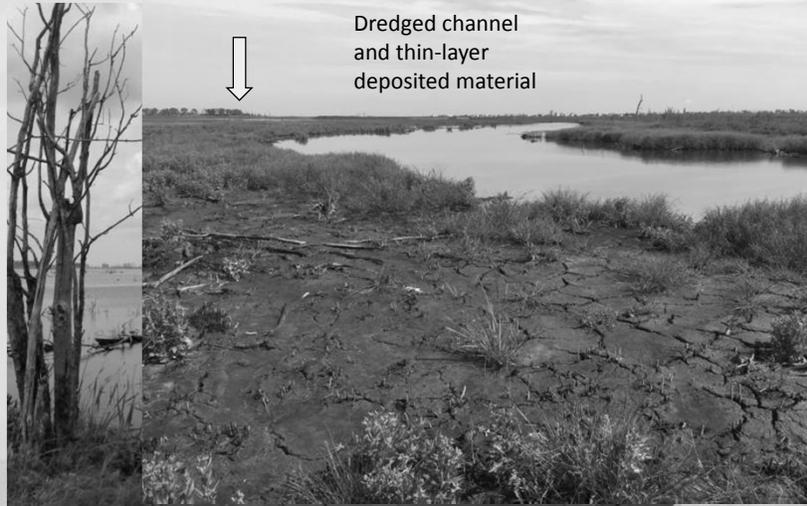
Dredged channel
and thin-layer
deposited material

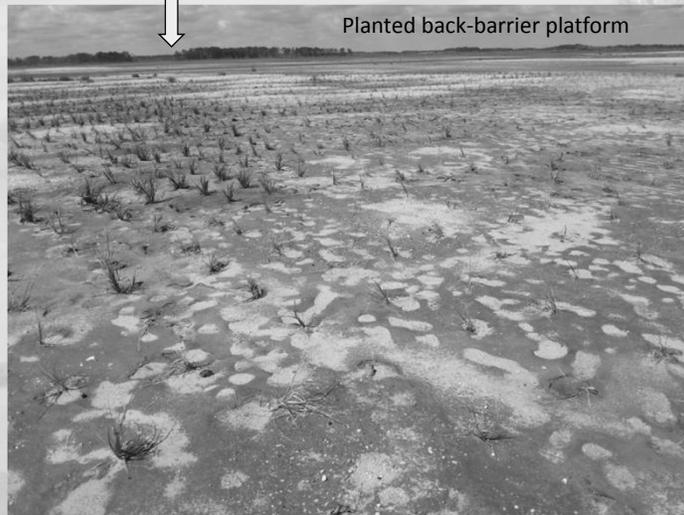
Planted back-barrier platform

- Building resiliency through stabilization of backbarrier
- Increasing seed stock
 - 40 acres, seeded with *Panicum*
 - 18 acres planted with *Spartina* grasses
 - 255,000 plugs of *patens*
 - 140,000 plugs of *alterniflora*

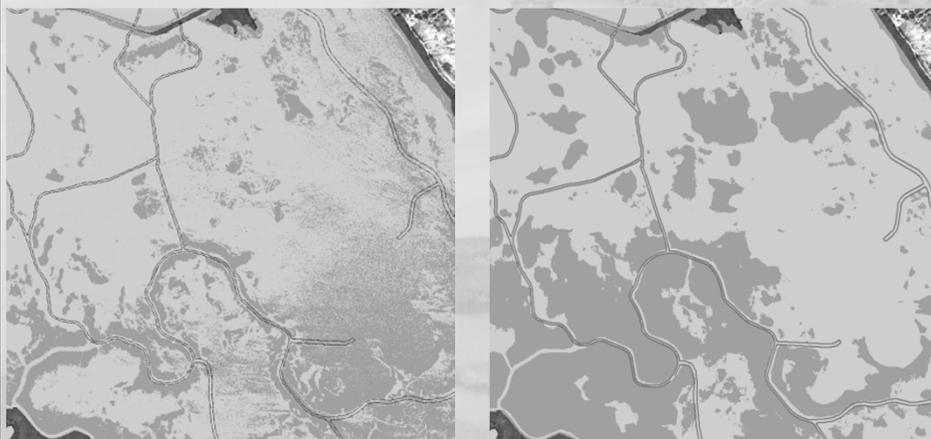
- Some large areas in Unit III adjacent to dredged channels, where material has been sidescast, filled in substantially

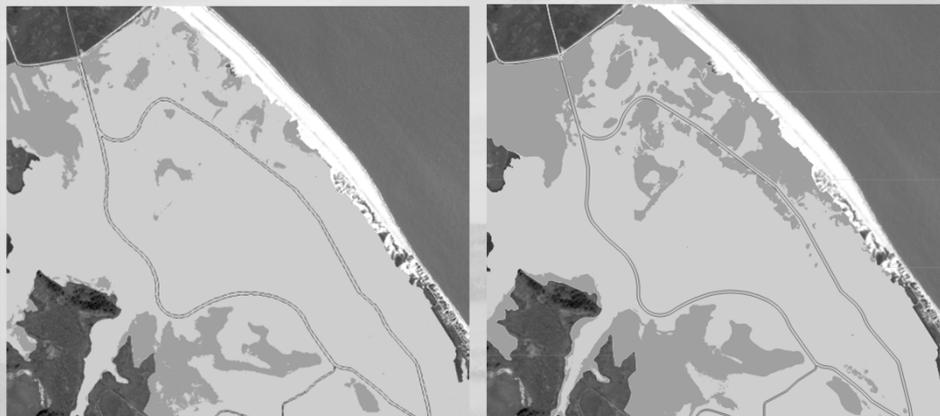
- Planted vegetation in back barrier area is evident (dune not included in analysis)
